Smoke and Dye Testing Summary

High Level Sewershed

Test ID	Test Type	Date Inspected	Company / Super.	Nearest MH	Ground Condition	Notification Made?		
D1028-166	Dye	4/29/2009	ADS/TM	S13AA1014MH	Damp	NA		
Address	Towanda Avenue & Springhill Ave		Location	Paved asphalt	Status	Public	Source	Storm Manhole

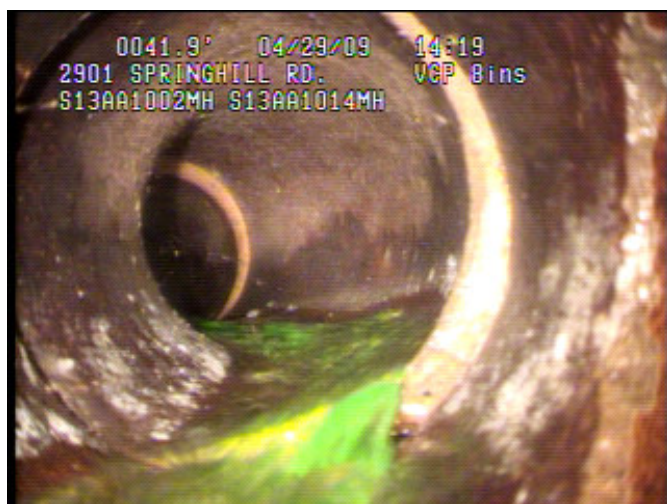
Picture \D1028-166-OB01-P01.jpg

Comments Dye observed 41.9 ft. upstream of S13AA1002MH. Infiltration gusher from service lateral at 9 oclock.

Comments 41.9 ft. upstream of S13AA1002MH along S13AA1014G1 at service lateral.

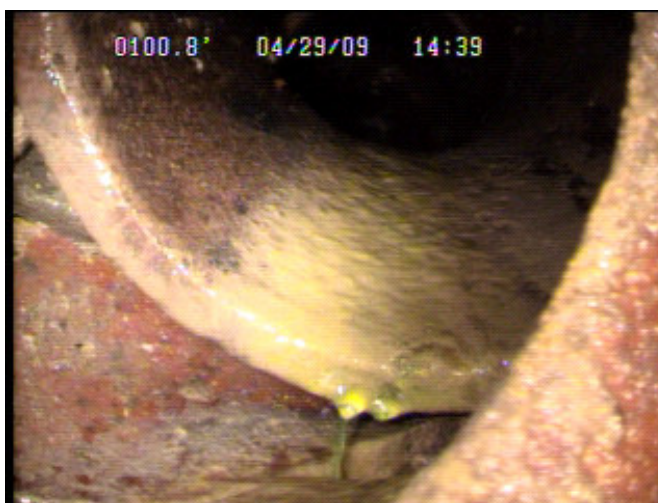
Picture \D1028-166-OB02-P01.jpg

Comments Dye observed 100.8 ft. downstream of S13AA1002MH. Infiltration dripper at service lateral at 2 oclock.

Comments 100.8 ft. downstream of S13AA1002MH along S13AA1002G1 at service lateral.
